# Beyond Root Custom Firmware For Embedded Mobile Chipsets

# NFC Controller – S3FWRN5

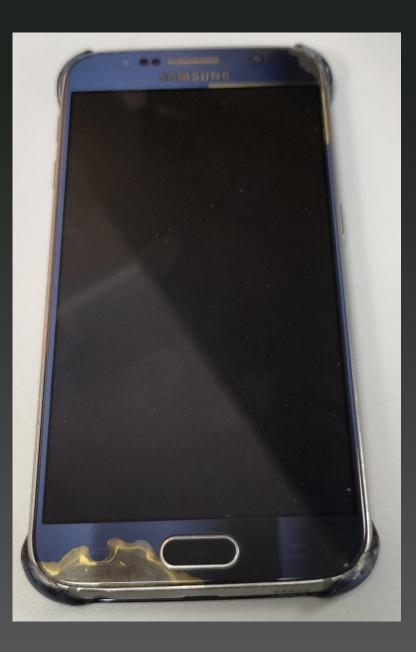
Samsung S6 - SM-G920F

Older smartphone – readily available

Allows for OEM unlocking and deployment of Custom ROMs

Found to use a proprietary Samsung Semiconductor NFC Controller in non-US versions

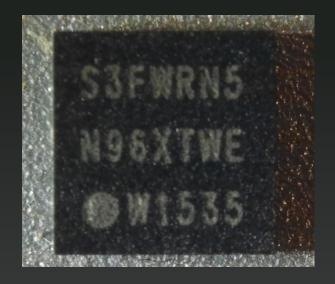
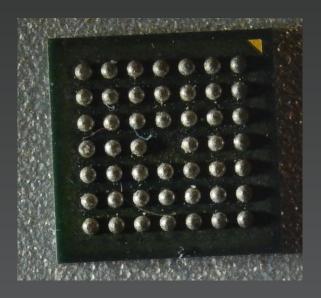
Custom chip developed by Samsung Semiconductor

Utilises ARM SC000 SecurCore architecture

Communicated with via I2C and GPIO on phone

Communication abstracted to device driver: /dev/sec-nfc

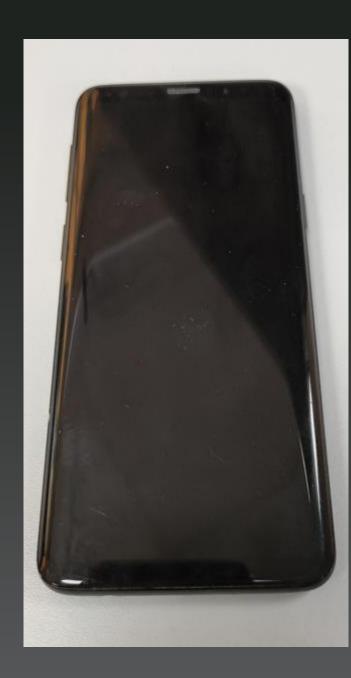
Found in Samsung Galaxy S9

S9 was purchased, and rooted using OEM unlocking and a Custom ROM

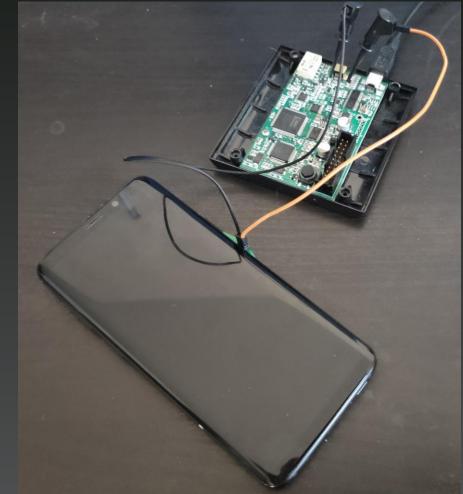
A goal was to emulate a Mifare Classic tag in its entirety on the S9

A Proxmark was used for debugging

NCI commands to initialise device were dumped from phone and replayed
